# UNDERWATER BRIDGE INSPECTION REPORT

STRUCTURE NO. 5853

THE SOUTH BRANCH OF THE BUFFALO RIVER

DISTRICT 4 - CLAY COUNTY

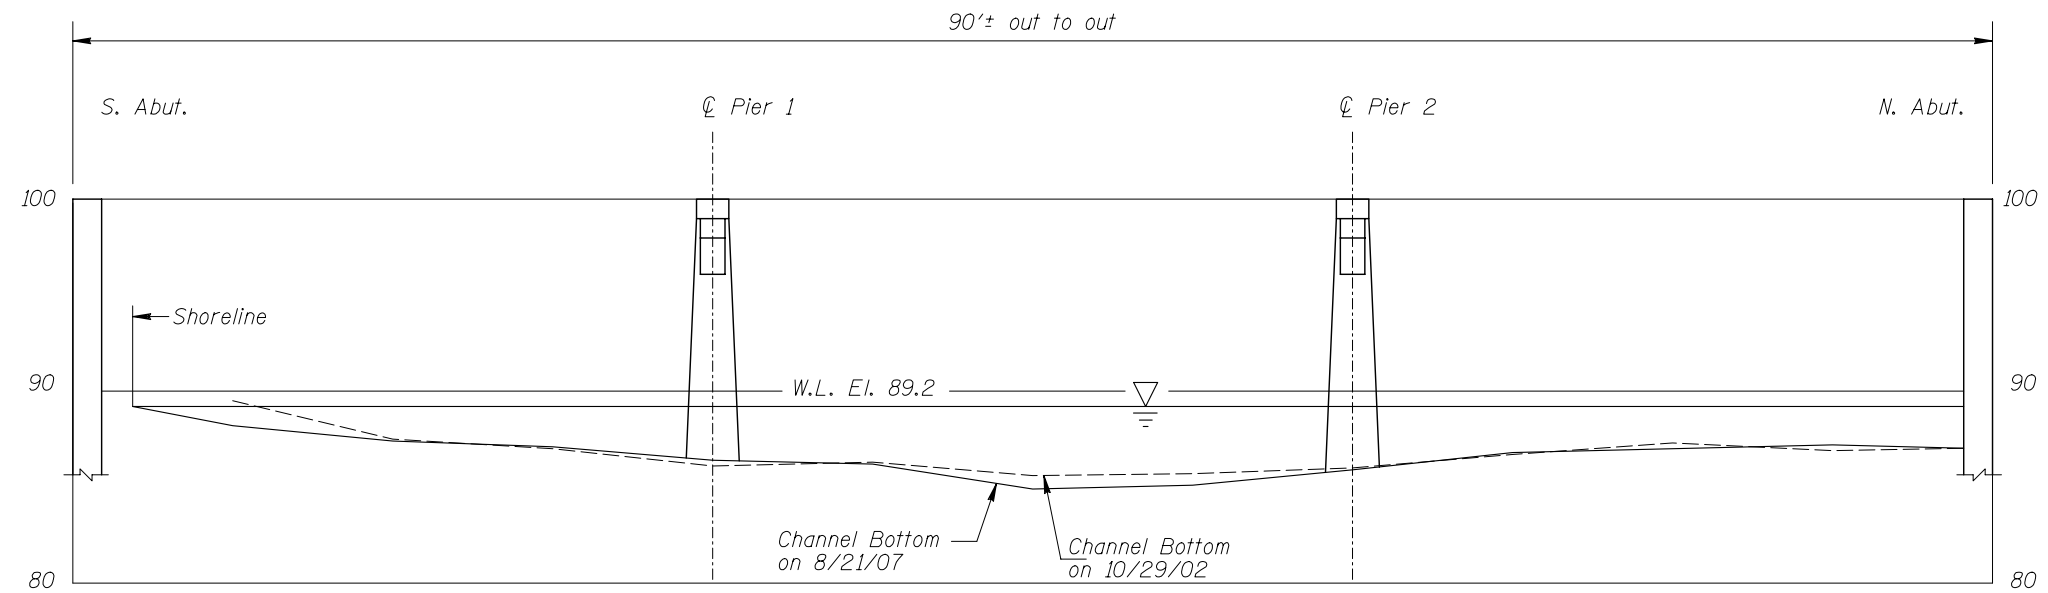
TYPICAL END VIEW OF PIERS

- 3 The concrete columns of Piers 1 and 2 were smooth and sound with random minor areas of poor consolidation with 1/4 inch maximum penetration.
- 4 The concrete of the abutments was typically smooth and sound with minor vertical and diagonal cracks at random locations, ranging in width from hairline to 1/8 inch.

- 5 A light accumulation of 6-inch-diameter and smaller branch timber debris was observed at the upstream side of the upstream column of Pier 2. The debris extended from the channel bottom to the waterline and was approximately 10 feet long (E/W) by 5 feet wide (N/S).

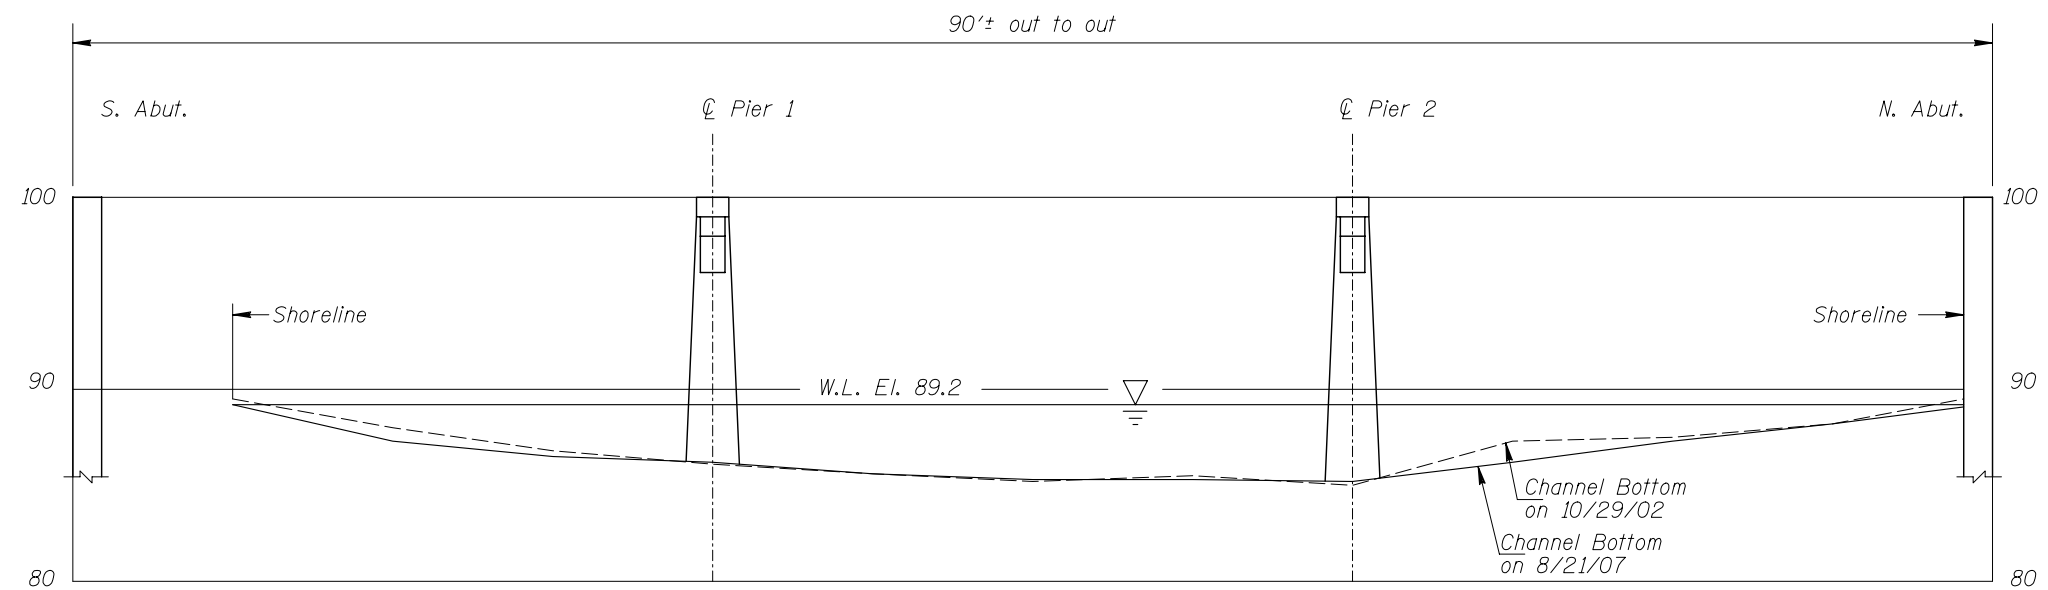
UPSTREAM FASCIA PROFILE

- 6 Abandoned concrete columns (two total) were observed in the channel at 8 feet North of South Abutment. The columns were removed below the channel bottom; however, the rebar from the columns extended from the bottom up to 1 foot above the waterline.
